Manhole Inspection Summary

Manhole # S31AA_026MH

Location Address: **801 MADISON ST**

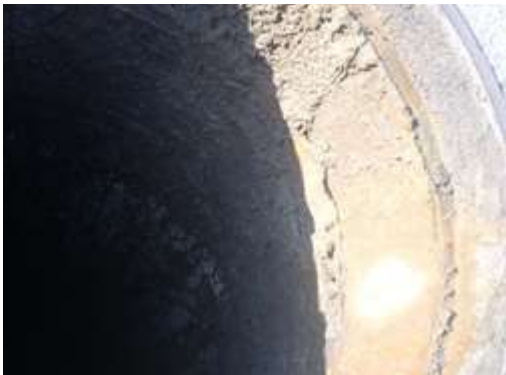
Defect 3

SURCHARGE EVIDENCE ON WALL

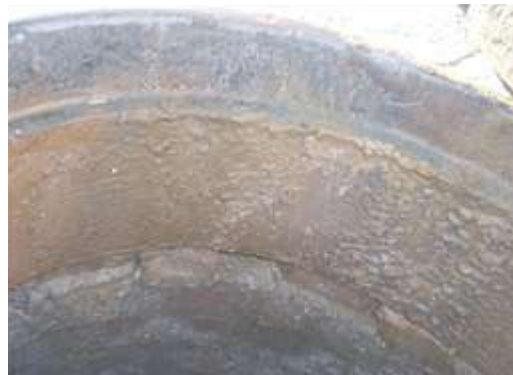
Defect 2

Condition: ☐ Sound ☐ Cracked ☐ Root Intrusion ☐ Loose Brick ☒ **Deteriorated**

CHIMNEY DETERIORATION

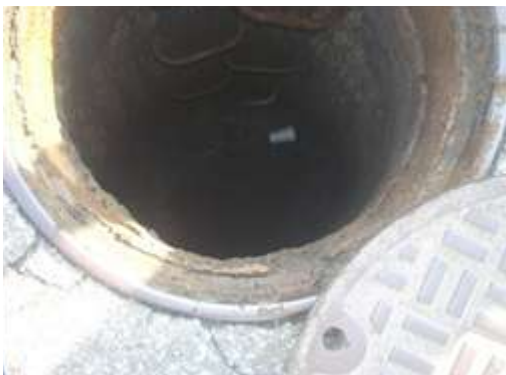
Defect 1

Offset: **0.5** (in.)

Count: **6** Missing: **0** ☒ **Corroded**

FRAME OFFSET/STEPS CORRODED

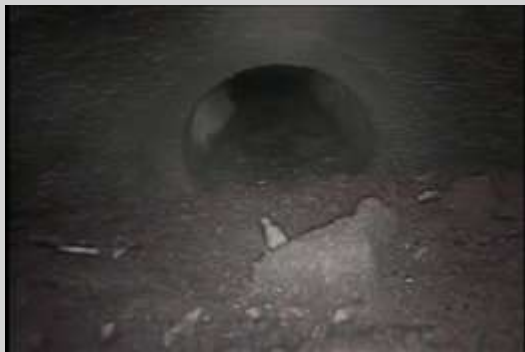
12 O'Clock Outflow

8 in. Circular Gravity Sewer
Pipe Out @ 12 O'Clock

Deposits: ☐ None ☐ Mud ☐ Sludge ☒ **Debris** ☐ Grease

Silt Depth: **2** (in.) Deposits Extent: **Medium**
